Customer magazine

up²date

ALWAYS IN ACTION –
IDEAS AND PROJECTS 24/7

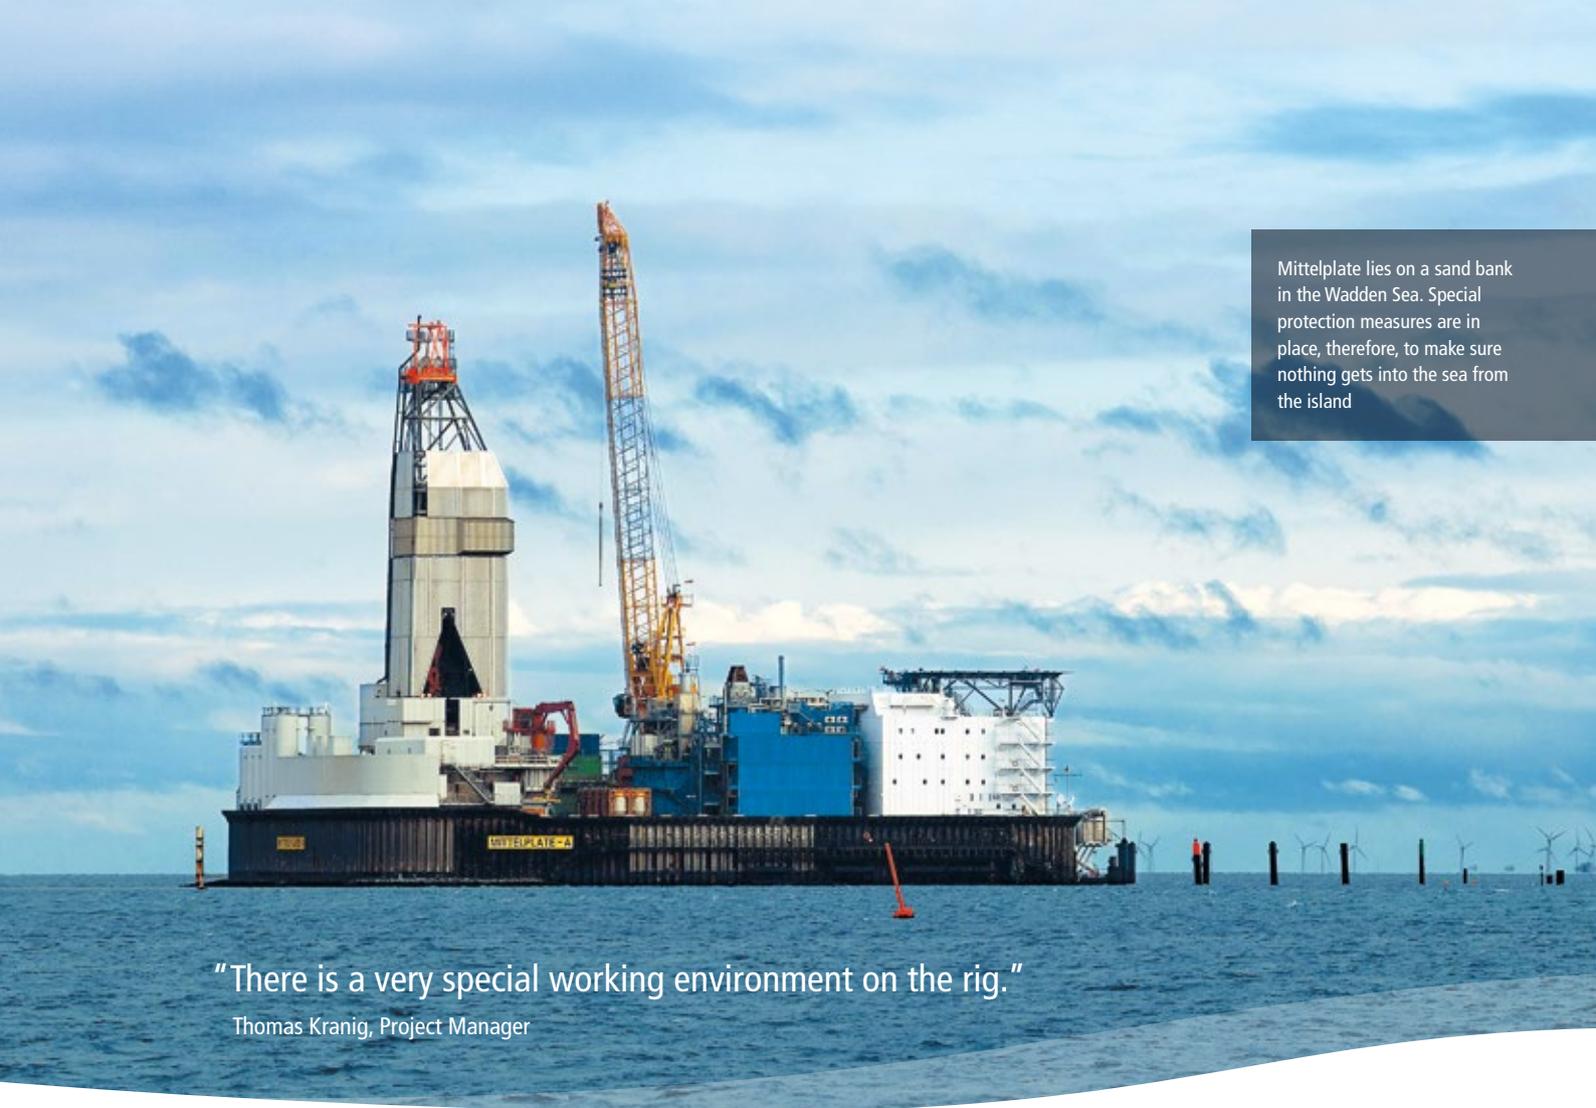
Mittelplate lies on a sand bank in the Wadden Sea. Special protection measures are in place, therefore, to make sure nothing gets into the sea from the island

The drilling and production island is built on a sand bank in the shape of a compact, leak-proof steel and concrete basin. The high sheet pile walls surrounding the rig protect it from the forces of nature. Nothing can escape from the island – even rainwater and spray is collected and treated. Seepage is not possible either. A comprehensive waste management system has been put in place to protect the Wadden Sea and North Sea. A variety of complex monitoring and control systems safeguard the drilling operations.

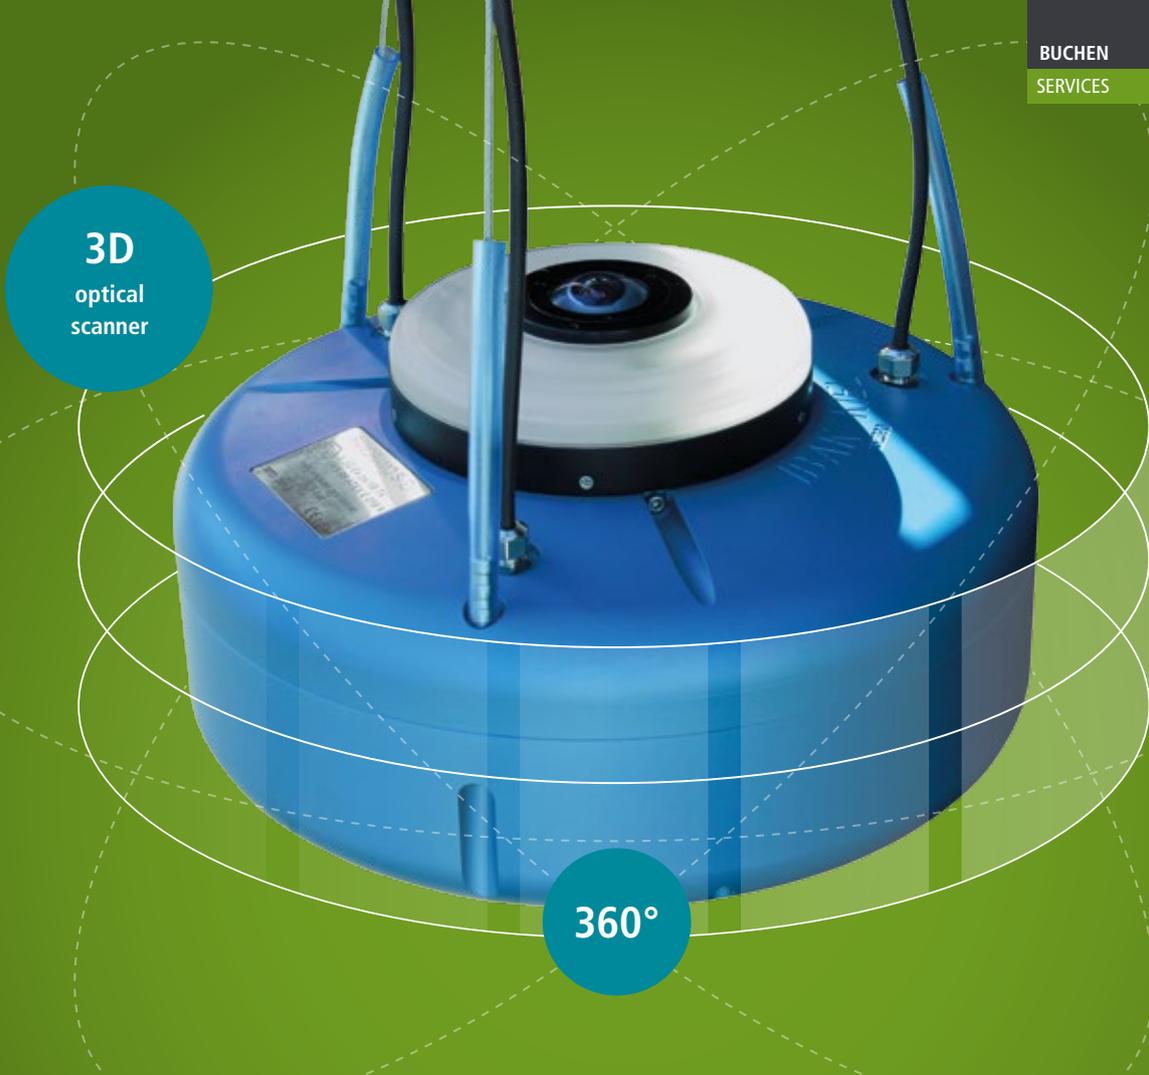
BUCHEN's sewer service division in Cologne recently acquired a state-of-the-art 3D optical scanner which allows the condition of manholes and other vertical structures to be assessed in a completely novel way. Attached to a special camera cable, it can be lowered into the manhole. As it slowly moves upwards, it automatically takes individual images of the surface (every 5 centimetres) which are then transformed by computer into a three-dimensional image. The result is a detailed and extremely realistic picture of the inside of the manhole.

After the work has been completed, the operatives or the clients can then go on a virtual tour. They can move up and down, zoom in and out and rotate the image – allowing them to make an exact analysis of the general state of the structure. This technology has considerably shortened the time needed for damage assessment projects: in the past this work could only be done by operatives climbing into a manhole wearing extensive safety equipment and manually collecting the data themselves. Depending on the quality of the wastewater, they sometimes had to put on full body protective suits and use breathing apparatus.

The BUCHEN team can now perform additional tasks thanks to its new 3D optical scanner system: not only inspections below ground but now also high up in the air. The camera is perfect for assessing the condition of industrial chimneys. Their latest project: the three chimneys at the central heating plant at the exhibition centre in Cologne.

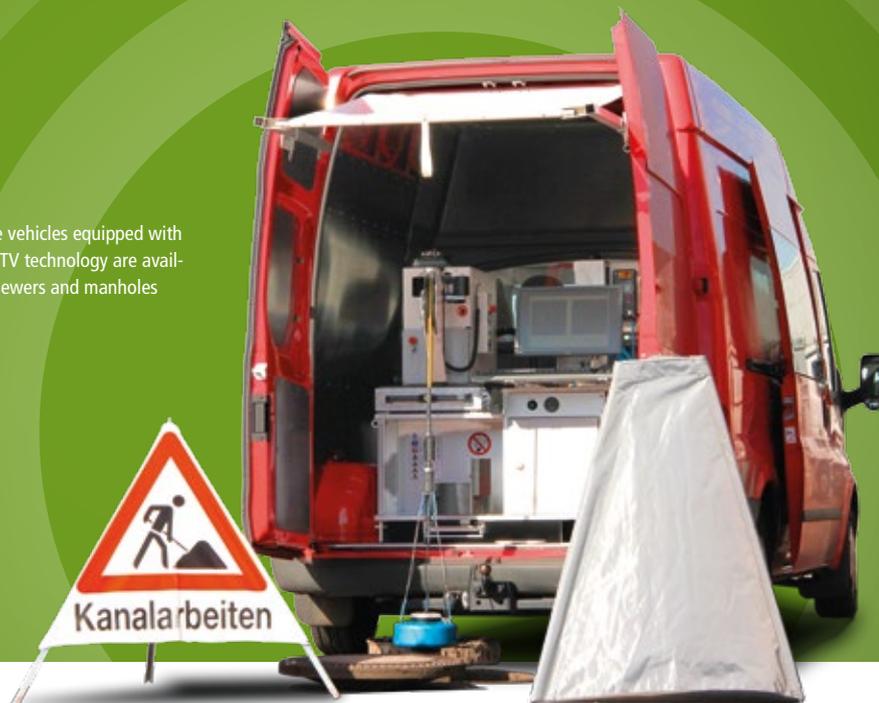
14 sewer service vehicles equipped with cutting-edge CCTV technology are available to inspect sewers and manholes

these specialist tasks. Their technology includes, for example, mobile camera systems, which can be attached to a variety of robotic crawlers and guided through the pipes by remote control or – if the robotic crawlers are too wide – pushed through the pipes. As the camera makes its way along the drains and pipes, it films the pipe network, digitally recording any damage so that the condition of the surface can be assessed. Pipes branching off from the main section can be examined using bendable cameras, so-called satellite cameras, which can be transported “piggyback” style. ►

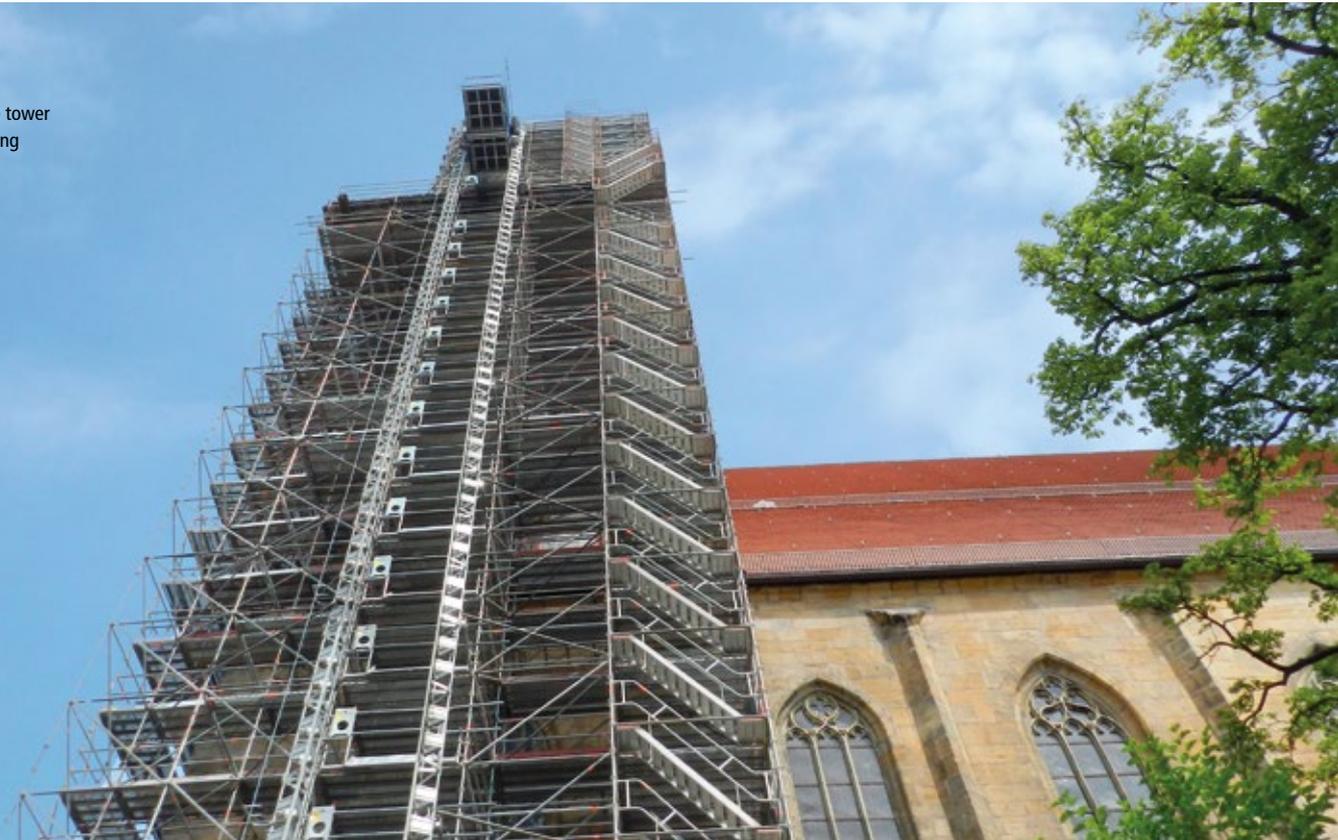
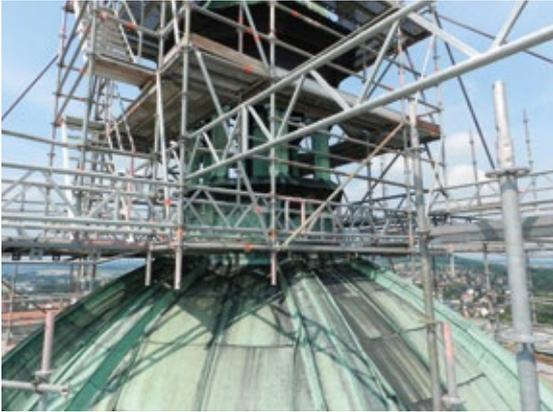
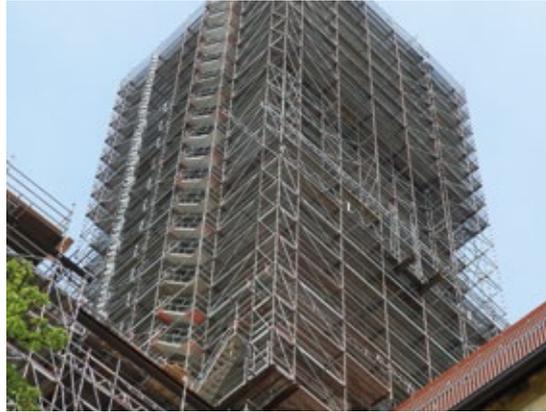
The Basilica's 92-metre tower surrounded in scaffolding

XERVON's scaffolding specialists planned and calculated every section of the scaffolding for the Basilica in Amberg right down to the tiniest of details – an impressive example of their scaffolding expertise

access to the tower and can perform their tasks efficiently. This structure safely transfers all the loads to a suitable load-bearing surface. Due to the local conditions, very few sections of the scaffold are able to directly bear loads and transfer them vertically to the base. To solve this problem, therefore, special constructions of bar joists and steel beams were designed and erected to re-direct and distribute the loads.

With all these special requirements and conditions having to be met, no part of this scaffolding is a standard construction – on the contrary, it is absolutely unique with every single section having been planned and calculated right down to the tiniest of details. The west side of the tower, for example, is 23 metres long and is right next to the edge of the River Vils which means that the scaffolding has had to be protected against the force of the water and possible floods. The scaffold has, therefore, been erected on a special sub-structure which can bear any excess loads generated by faster currents or floods. Special scaffolding was also needed on the east side, where a self-supporting scaffold structure has been erected above the surface of the roof of the nave. Any loads generated here are transferred either straight to the tower via a steel construction or to the scaffolding on the north and west-facing sides via heavy duty bar joists. The base of the scaffold on the north side was extended to enable it to bear these extra loads. A further tricky task had to be performed in this area: around 20 metres of freestanding scaffolding had to be erected here.

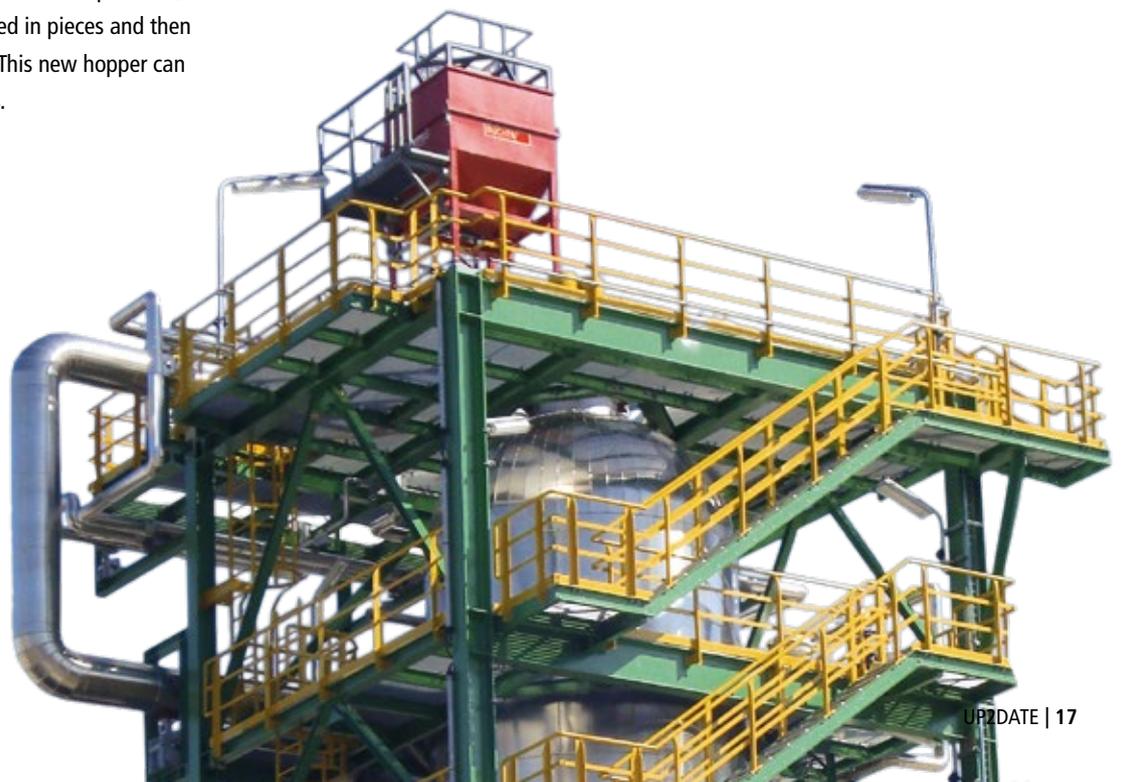
The new, safer hopper ready for use – during the filling process it is bolted securely to the top of the reactor so that it is unable to move

Whenever operatives fill a reactor – in this first case a reactor almost 65 metres high – they must make sure that the catalyst (a loose granular material) flows uninterrupted from the hopper into the inside of the reactor. To be able to do this, they use a crane to lift the material (packed in 1.5m³ big bags) off the ground and empty it into the hopper located at the top of the reactor. In the past, these big bags had to be opened and emptied whilst hanging from the end of the crane. This has all changed now: by altering the design of the hopper, the big bags can now be placed into the 3m³ container before they are opened. Detachable walkways have been installed along two sides of the container to provide the operative with a safe platform.

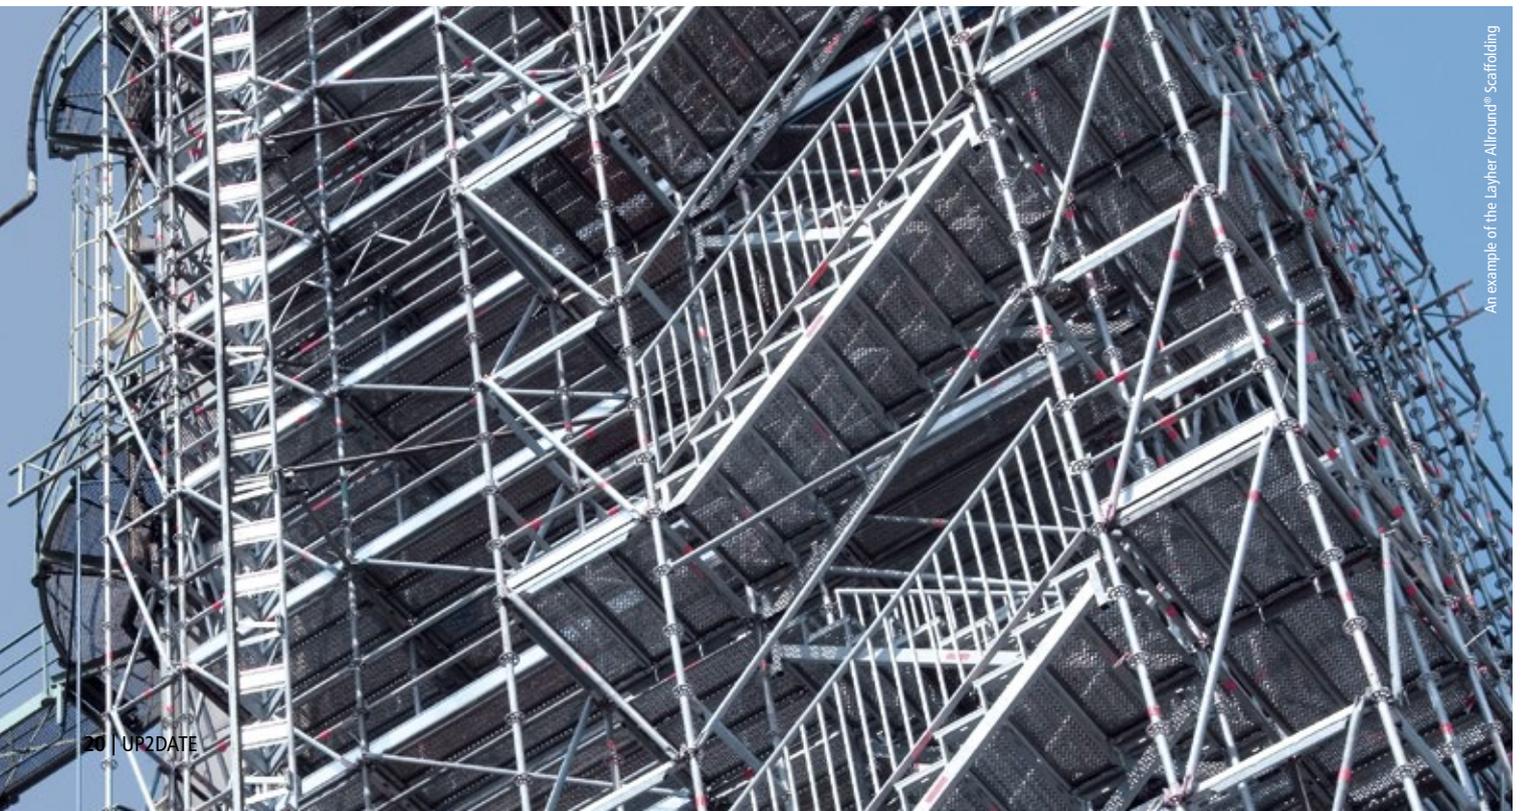
An example of the Layher Allround® Scaffolding

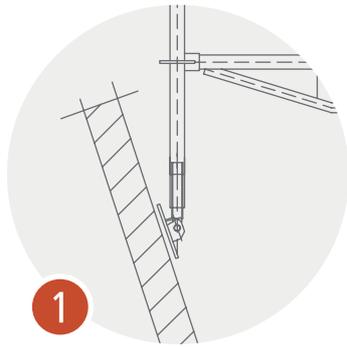
Swivel base jack

A detailed view of the specially designed scaffolding structure in the inside of the recirculation shafts

The scaffolders erected 25-metre-high scaffolding in the inside of each shaft (internal width: 1.46 metres) using an adjustable modular scaffolding system. “This meant we could react flexibly to the different dimensions of the shafts.” With such a tight schedule to keep to, the operatives worked almost around the clock so that the eight work platforms were erected and ready for use within a very short time indeed.

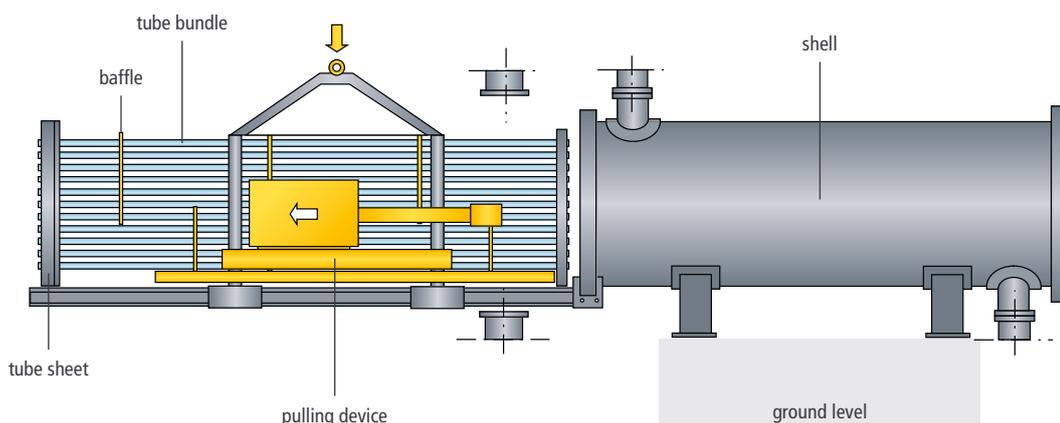
Bundle extraction system

An illustration of the system used to extract the tube bundle

Overhauling heat exchangers at refineries is most definitely a job that can only be performed by trained personnel. As was the case in Norway. To begin with, the heat exchangers had to be separated from the rest of the system, before the shell could be dismantled and the tube bundle extracted. Special equipment was used by the maintenance experts at this point to ensure this decisive step was carried out without incident.

Once this had been done, a crane was used to place the bundle on a low loader trailer so it could be taken to a central washing area where it was washed, checked and, if needed, repaired – a task for the refinery's own personnel or another contractor. As soon as this work had been completed, XERVON's maintenance staff reassembled the heat exchanger. The same special machine used to pull the bundle out of the heat exchanger was adjusted so it could push it back in. A pressure test was then performed once all the
